# Determination of earthquake resistance of historical masonry inn with finite element analysis

**Keywords** Finite element analysis · Historical inn · Seismic performance · Durak Han

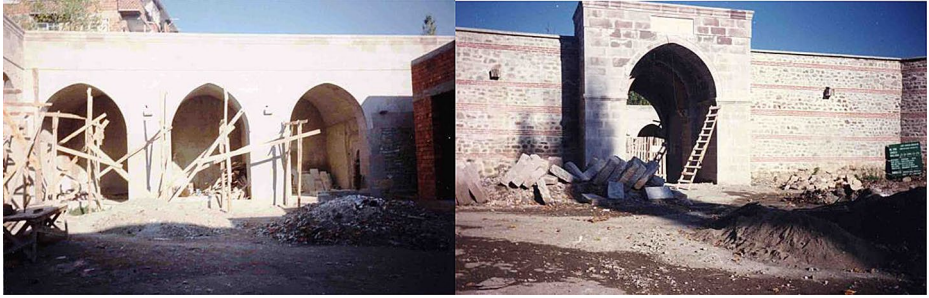
**Fig. 7** 3rd period of inn photographs (inside the yard and entrance façade) (Conservation Report of Durak Han 2015)

The third period restoration can be read by the changes in the material and weave of the third period interventions. The third period represents the final restored version (Fig. 7).

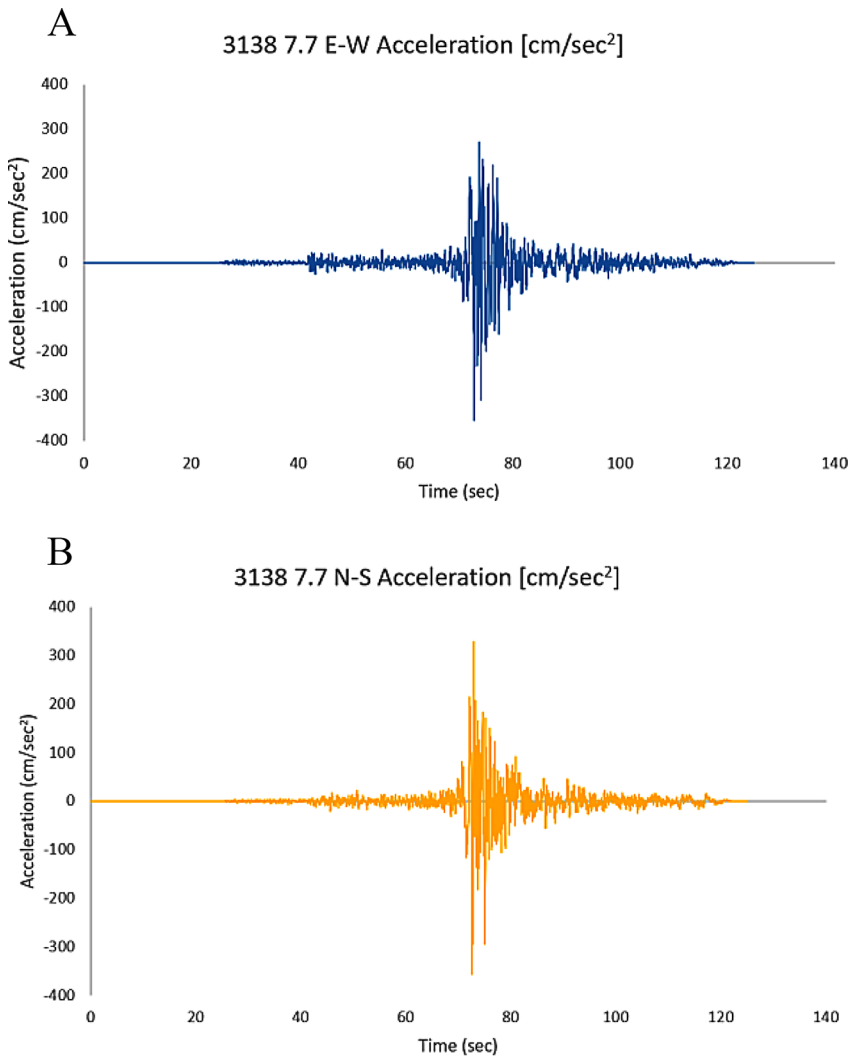
**Fig. 11** **A** Accelerogram of Antakya midtown (3138 St. E-W Dir.). **B** Accelerogram of Antakya midtown (3138 St. N-S Dir.)
