# Simplified FE-Based Post-Earthquake Vulnerability Assessment of a Partially Collapsed Historic Mosque

**Abstract:** On 6 February 2023, two major earthquakes struck southeastern Türkiye along the East Anatolian Fault, causing widespread structural damage, including the partial collapse of the historic Habibi Neccar Mosque in Antakya. This study presents a simulation-based approach to rapidly assess the seismic vulnerability of this partially damaged historic masonry structure. Due to the complexity and urgent condition of such heritage buildings, a simplified finite element (FE) modeling methodology is employed to evaluate structural behavior and support immediate stabilization decisions. Response spectrum analysis is applied to simulate and interpret stress distribution and deformation patterns in both undamaged and damaged states. The simulation results highlight significant tensile stress concentrations exceeding 0.2 MPa at dome–arch joints and vaults—primary indicators of localized failures. Additionally, the analysis reveals increased out-of-plane deformations and the influence of soil amplification in the remaining walls, both of which further compromise the structural int

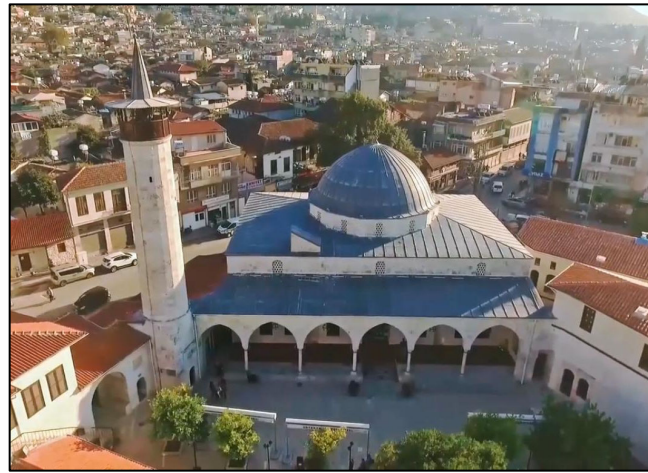
**Figure 2.** General view of Habibi Neccar Mosque before it was partially collapsed. This figure has been adapted from “Türkiye Kültür Portalı-Hatay Habibi Neccar Camisi” [40].

The Habibi Neccar Mosque was located on an ancient street that has existed since the foundation of Antakya, connecting the two ends of the city on a southwest–northeast axis. The structure has a rectangular plan with approximate dimensions of 30 m in width and 20 m in depth, including the last congregation area. The overall height of the building is approximately 13.5 m, and it reaches up to 25 m at the apex of the central dome. Based on visual inspection and reference to similar Ottoman-era structures, the wall thickness ranges between 0.9 and 1.2 m, and the vault thickness was assumed to be 0.35 m during modeling. As seen in Figure 2, the mosque, which is easily recognizable due to its larger mass compared to the other buildings around it and its location on the street, has the appearance of a complex consisting of madrasah rooms and a fountain. These parts are located around a trapezoidal courtyard and are bounded by the road to the east and south while connecting with neighboring parcels and roads in other directions [37]. The entrance to the mosque is through the crown door with a round arch with an inscription as well as a relief and pointed arch. As seen in Figure 3, the mosque has large, pointed arches on both sides and an interlaced vault. The circular main dome of the Habibi Neccar Mosque is supported by four large, pointed arches and pendants. There are 12 windows in the part forming the pulley of the main dome [38,39]. Figure 4 shows the dome, vaults, pendentives, arches, and walls in the schematic plan describing the general structural form of the mosque.

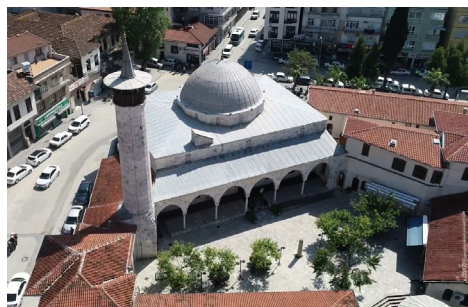
**Figure 5.** Habibi Neccar Mosque street lines. The figure has been adapted from “Hatay Governorship-Anadolu’nun ilk camisi” website [42].

Masonry walls are brittle and anisotropic, with high compressive strength but significantly lower tensile strength, making them particularly vulnerable to horizontal seismic forces [41]. Built using masonry stone elements, the Habibi Neccar Mosque is part of a larger complex that includes two mausoleums, madrasah sections, and a fountain. As seen in Figures 5 and 6, the complex does not follow a strict linear alignment, which may have influenced the structural response during the earthquake.

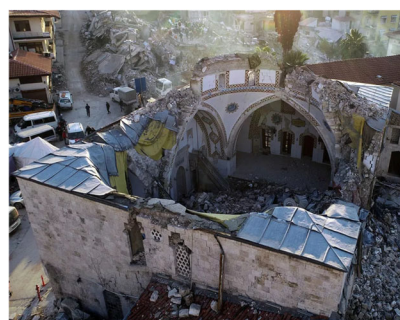
**Figure 7.** Complete collapse of the minaret and dome of the Habibi Neccar Mosque after the earthquake of Mw 7.7. The debris also affected the adjacent buildings on the southwest side. The figure has been adapted from the “DHA” website [43].

The mosque sustained severe damage during two large earthquakes (Mw 7.7 and Mw 7.6) on 6 February 2023, causing partial collapse of the structure and complete collapse of the minaret (Figures 7 and 8). The minaret, located southwest of the mosque, collapsed onto the adjacent buildings, affecting the walls of the complex. However, the surrounding complex walls and the fountain remained undamaged, indicating that the damage intensity was more severe for the primary load-bearing elements of the mosque.

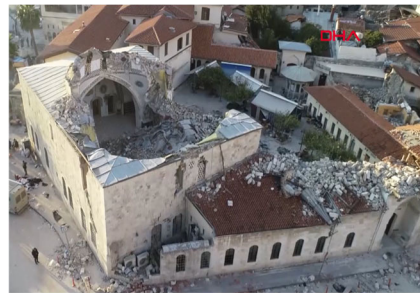
**Figure 8.** Collapse of the west wall and partial roof failure of the Habibi Neccar Mosque, with debris indicating the fall of the minaret onto adjacent structural elements. The figure has been adapted from the “DHA” website [43].

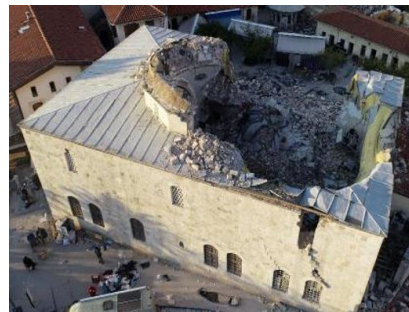
**Figure 9.** Aerial view of the Habibi Neccar Mosque showing visible shear cracks along the south walls. This figure has been adapted from the “DHA and istockphoto” website [43,44].

Shear cracks in the south and east walls caused by window openings can be seen in Figures 9 and 10, indicating the effects of lateral seismic forces. Figure 9 illustrates the formation of shear cracks along the southern and eastern walls, especially near the apertures. The cracks indicate the lateral seismic forces exerted on the unreinforced masonry walls during the earthquake. Figure 10 illustrates diagonal shear cracking on the southern wall of the mosque, especially in the vicinity of the window area. This damage indicates a common failure mode resulting from horizontal seismic forces impacting unreinforced masonry. The west wall of the mosque (Figure 11) collapsed completely, while the north

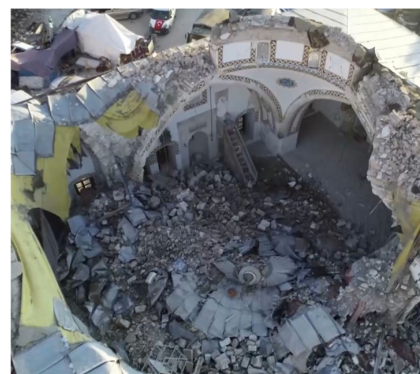
**Figure 11.** Interior view showing the collapse of the mosque's west wall, while the north and east arches that support the dome remain standing. This figure has been adapted from the “DHA” website [43].

and east arches supporting the dome survived. The damage pattern suggests a significant compromise in the mosque's structural integrity, with localized damage accumulating in the most vulnerable areas.
